Case Study

Client	Haryana Irrigation Department
Gripple Terra-Lock™ System	TL-304, TL-A3, TL Pins and G-MAT T50
Application	Hydraulic and Slope Stablity, Erosion control

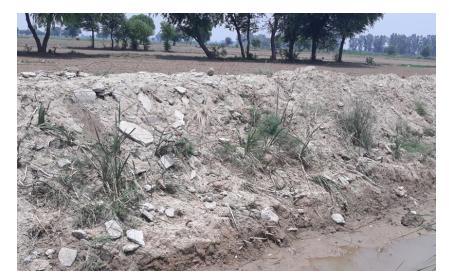
Failure of the concrete in drain canal

The Beri-Dujana Drain Canal is located in Jhajjar - Haryana in India. Previously concrete was used to line the bed and embankment of the drain canal, however over time it started to fail in various places due to erosion caused by water inflow from the surrounding fields and from water passing through the drain. There were failures of the embankment toe and concrete lining on the bed of the channel due to pore water pressure, and failure to the entire concrete lining along the embankment.

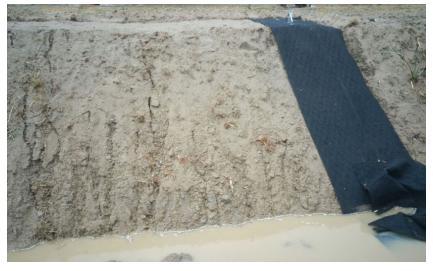
During installation of Gripple solution

The Gripple Terra-Lock[™] system, comprising of TL-304 Anchors, TL Pins and G-MAT T50 was proposed and installed for a test length of approximately 15 meters and 3.5 to 4 meters high. The solution met all of the above requirements as the system allows water flow without soil loss and by design stabilises the structure.

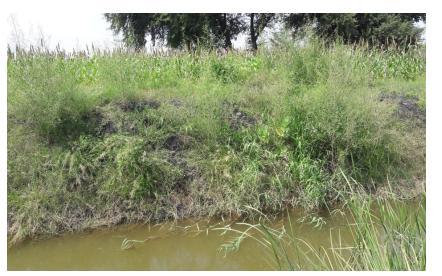
80 days after installation
